NEWPORT M.U.D. CAPITAL IMPROVEMENT PLAN

NEWPORT M.U.D. WASTEWATER TREATMENT PLANT & LIFTSTATIONS

NEWPORT M.U.D. SANITARY SEWER TV INSPECTION

SURFACE WATER TREATMENT PLANT & WATER DISTRIBUTION

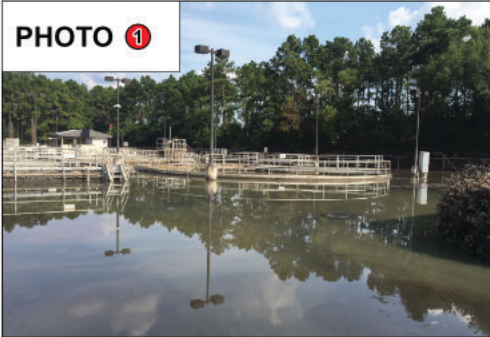
PHOTO ①

Problem: Wastewater Treatment Plant (WWTP) facilities flooded.
Solution: Repair damaged facilities & flood proof plant facilities.

WWTP Underwater – Hurricane Harvey, Aug. 2017

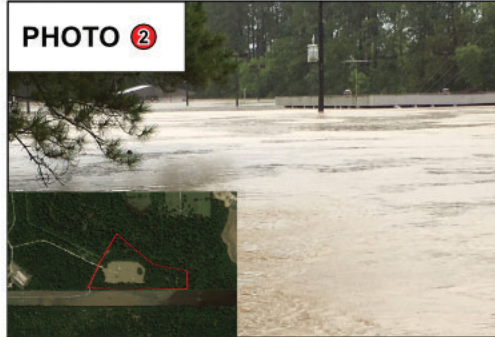
PHOTO ②

Problem: Wastewater Treatment Plant (WWTP) facilities flooded.
Solution: Repair damaged facilities & flood proof plant facilities.

WWTP Underwater – Hurricane Harvey, Aug. 2017

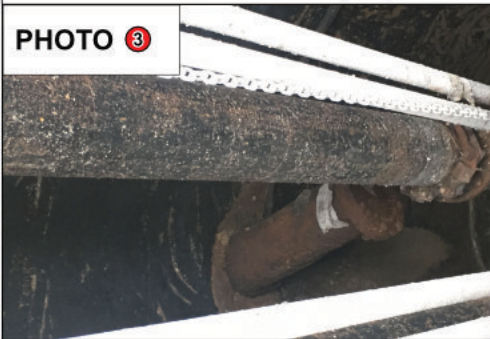
PHOTO ③

Problem: Coal tar liner is showing signs of deterioration and riser piping is corroding.
Solution: Line wet well and replace riser piping.

Lift Station No. 4 (931 Flying Bridge Way)

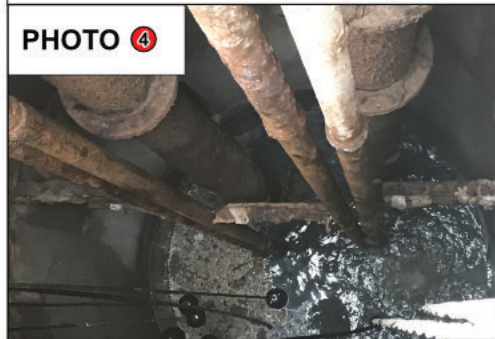
PHOTO ④

Problem: Severely corroded riser piping with I/I in wet well.
Solution: Replace riser piping & line wet well.

Lift Station No. 3 (1212 S. Diamondhead Blvd)

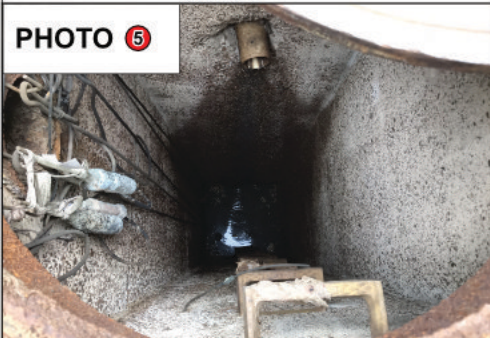
PHOTO ⑤

Problem: Deteriorated wet well and riser pipes corroding.
Solution: Line wet well and replace riser piping.

Lift Station No. 6 (818 Handspike Way)

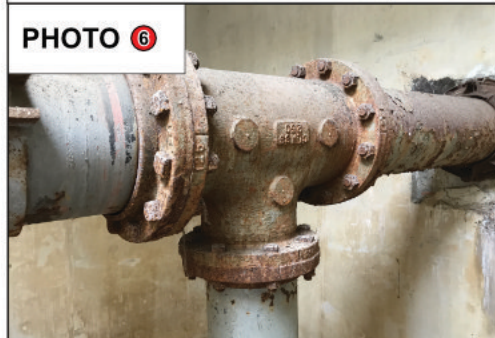
PHOTO ⑥

Problem: Deteriorated wet well and riser pipes corroding.
Solution: Line wet well and replace riser piping.

Lift Station No. 1 (514 Helmsman St)

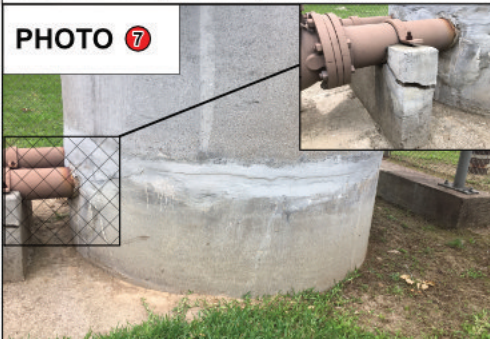
PHOTO ⑦

Problem: Large radial crack around exterior of wet well and major cracking on pipe supports.
Solution: Line wet well and replace pipe supports.

Lift Station No. 7 (15727 Via Dora)

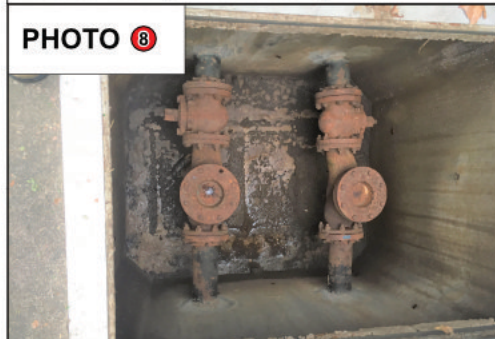
PHOTO ⑧

Problem: Corroded valves and brick vault with limited working space.
Solution: Replace valves and move to surface.

Lift Station No. 5 (1310 1/2 Stem Way Dr)

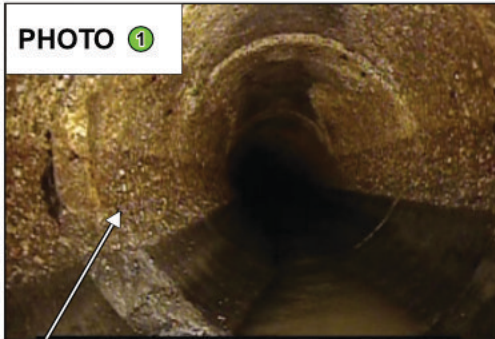
PHOTO 1
Problem: Broken 24" Reinforced Concrete Pipe at Joint.
Solution: Pipeburst Method.
Newport Section 1

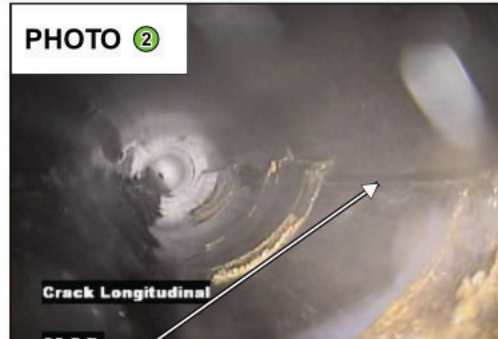
PHOTO 2
Problem: Longitudinal Crack with Signs of Infiltration in 8" Truss Pipe.
Solution: Cured-In-Place Pipe Method.
Newport Section 10

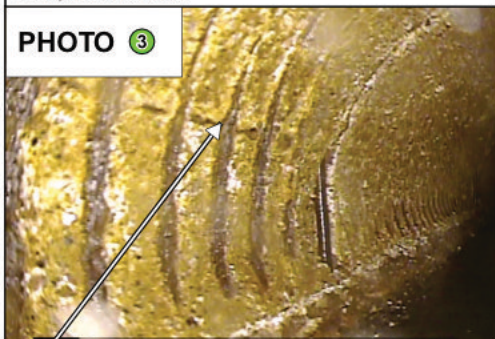
PHOTO 3
Problem: Severe Deterioration of 18" Reinforced Concrete Pipe to the point of reinforcement now exposed.
Solution: Cured-In-Place Pipe or Pipeburst Methods.
Newport Section 6

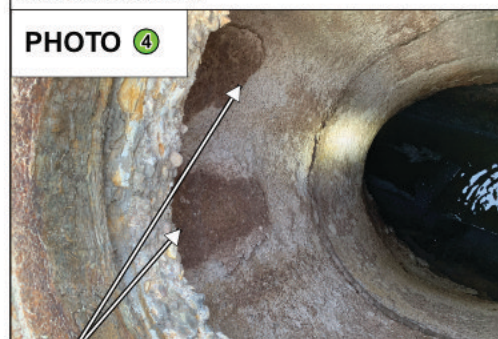
PHOTO 4
Problem: Severe degradation with exposed aggregate and spalling concrete on 48" trunkline manhole.
Solution: Install liner or replace manhole.
Newport Section 10

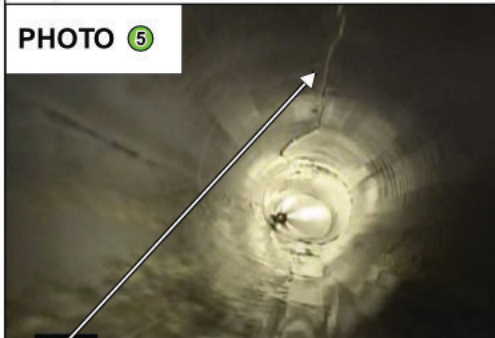
PHOTO 5
Problem: Longitudinal Crack at top of 12" Truss Pipe.
Solution: Pipeburst Method.
Newport Section 2 and Oaks at Newport Section 1

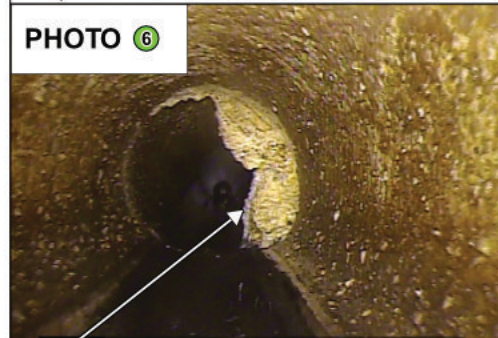
PHOTO 6
Problem: Heavy Deposit buildup at the joint due to Infiltration and Inflow (I/I) over time.
Solution: Pipeburst Method.
Newport Section 1

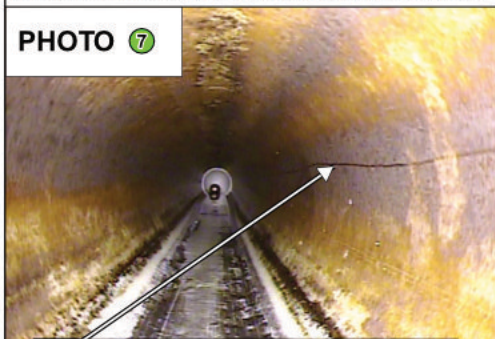
PHOTO 7
Problem: Longitudinal Crack travelling as far as 10 feet in length.
Solution: Pipeburst Method.
Newport Section 1

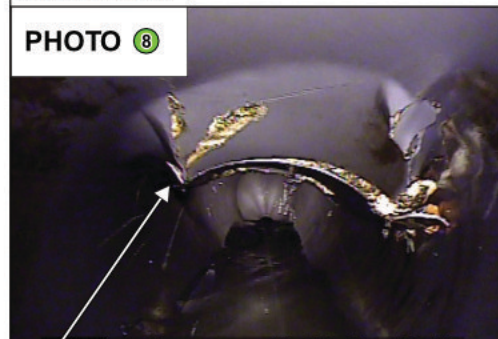
PHOTO 8
Problem: Defective/Intruding Service that is causing buckling and broken pipe.
Solution: Pipeburst Method.
Newport Section 3 and Newport Section 6

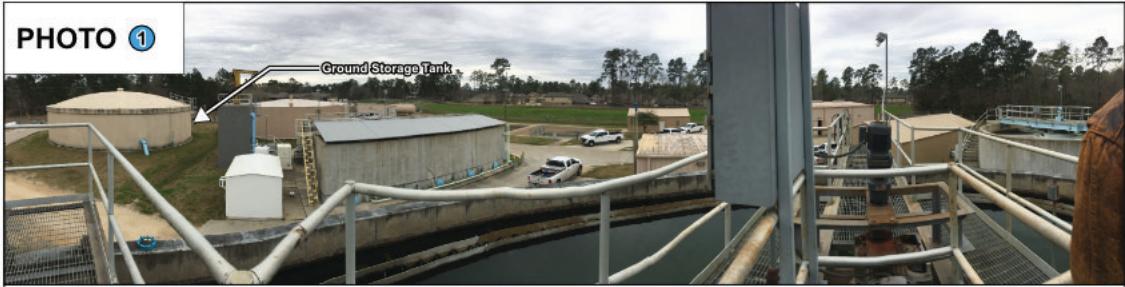
PHOTO 1

Surface Water Treatment Plant Problem: Surface Water Treatment Plant will not meet peak flows at ultimate buildout.
Solution: Expand Surface Water Treatment Plant.

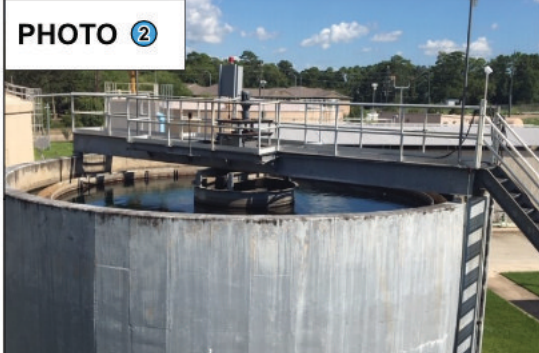
PHOTO 2

Surface Water Treatment Plant Clarifier Problem: Tonka Clarifier is not working properly and is now out of service.
Solution: Repair Clarifier before further damage occurs.

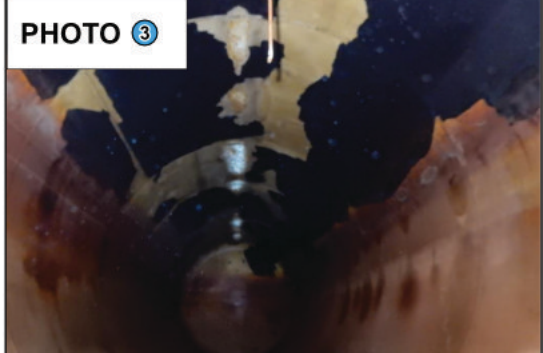
PHOTO 3

Hydro Tank Problem: 80% of interior coating has deteriorated over time, and metal is beginning to corrode.
Solution: Replace Hydro Tank due to severity of the conditions.

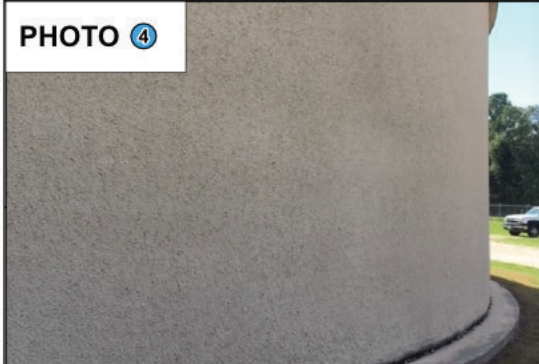
PHOTO 4

Ground Storage Tank Problem: Ground Storage Tank coating is deteriorating on exterior.
Solution: Recoating of exterior surface.

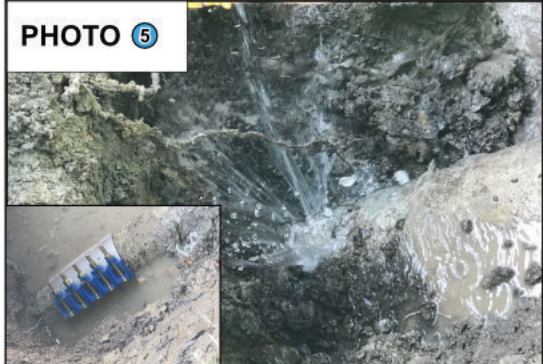
PHOTO 5

Water Distribution Main Line Problem: Water Main break due to aging distribution line.
Solution: Water System Rehabilitation.

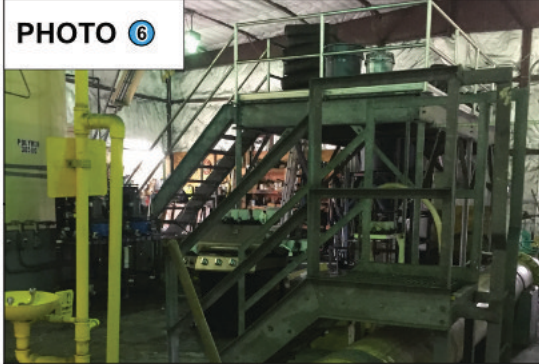
PHOTO 6

Surface Water Treatment Plant Problem: The space and access is limited.
Solution: Improve and maximize space during Plant Expansion.

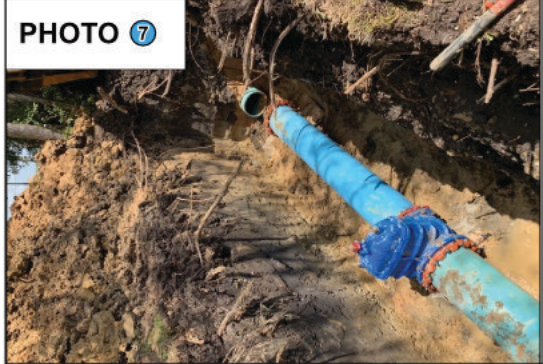
PHOTO 7

Water Line Valve Problem: Water line valves are aging and need to be evaluated.
Solution: Valve survey and replacement program.

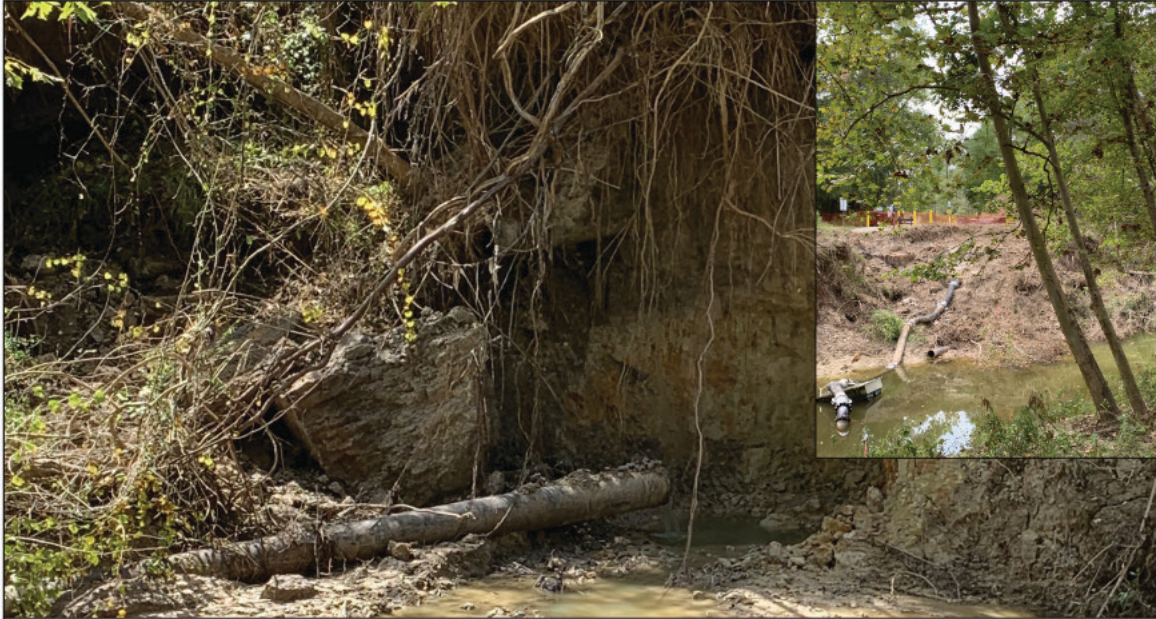
Force Main Collapse – Tropical Storm Imelda, Sept. 2019

Problem: Force main collapse near Lift Station No. 6 at 818 Handspike Way.
Solution: Emergency repair of broken force main including temporary pumping.

Emergency Repair Cost: \$158,000

Planned Rehabilitation Cost: \$95,000

Percent Cost Increase for Emergency Repair: 40%

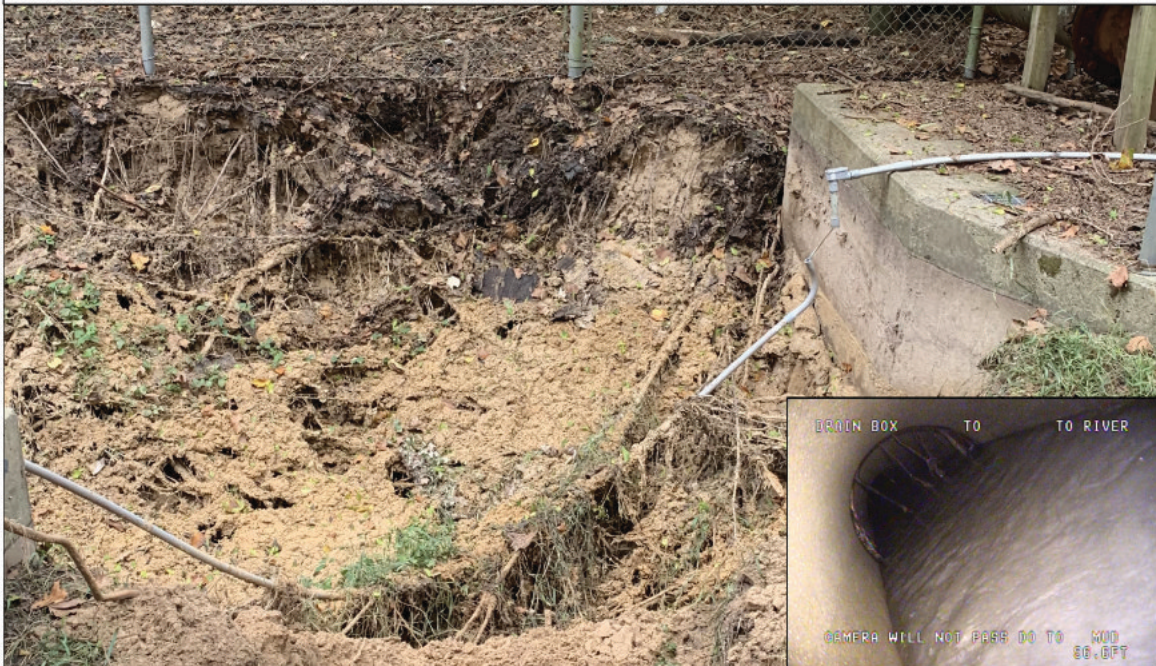
WWTP Sinkhole – Tropical Storm Imelda, Sept. 2019

Problem: Large sinkhole and broken pipes.
Solution: Repair broken pipes by joint repair, backfill sinkhole & stabilize.

Emergency Repair Cost: \$146,000

Planned Rehabilitation Cost: \$88,000

Percent Cost Increase for Emergency Repair: 40%
